## VERIFICAÇÃO DAS REDES PROFIBUS DE REIS MAGOS

### COMPARATIVO GRÁFICO TENSÃO/DISPOSITIVO

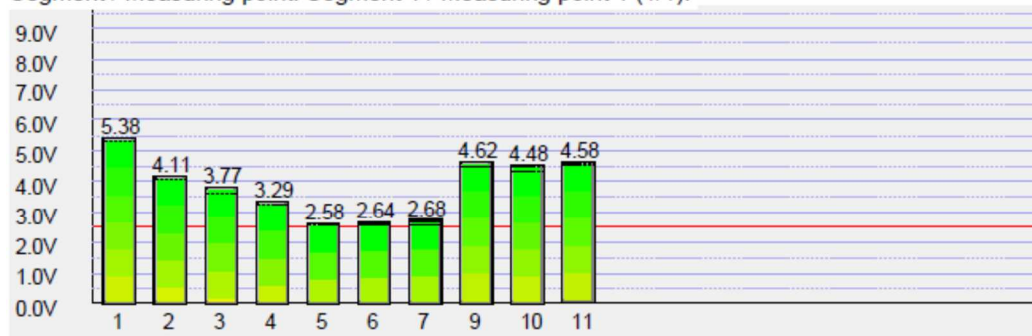
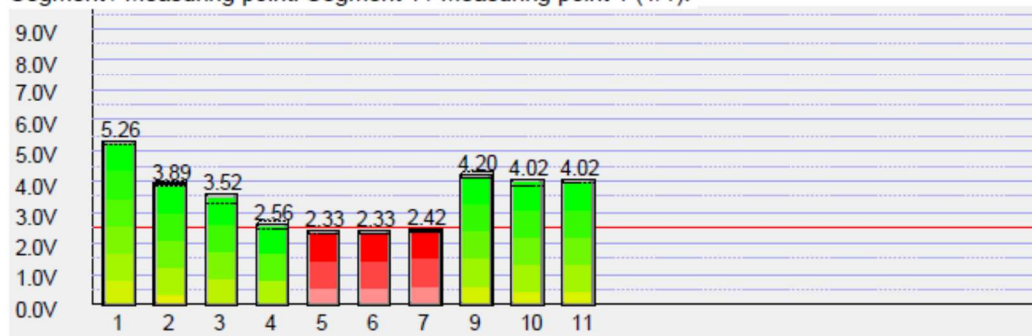
Figura 1 - Antes da intervenção

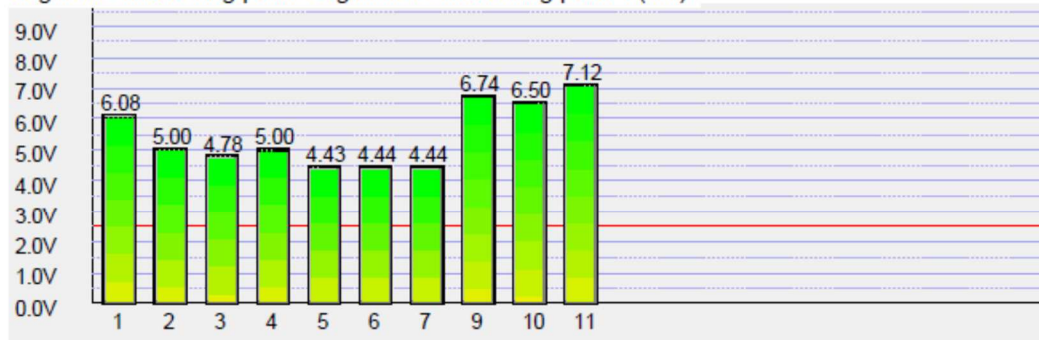
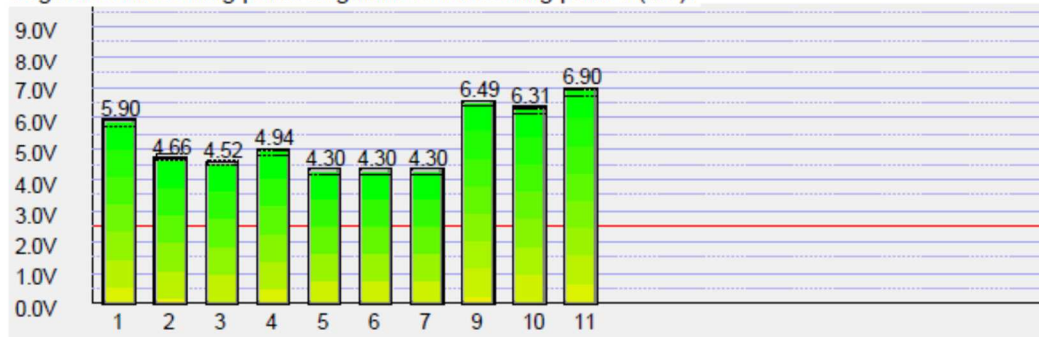
Figura 2 - Após a intervenção

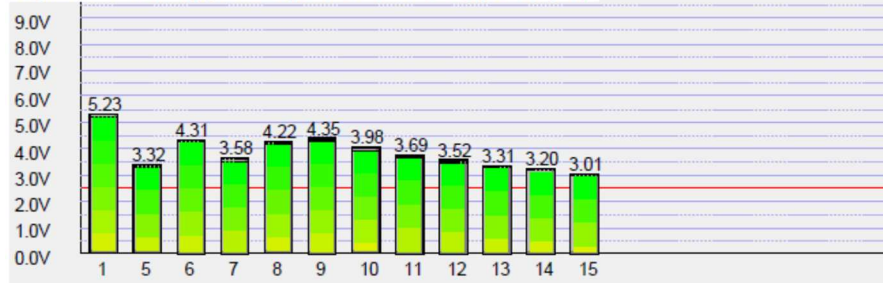
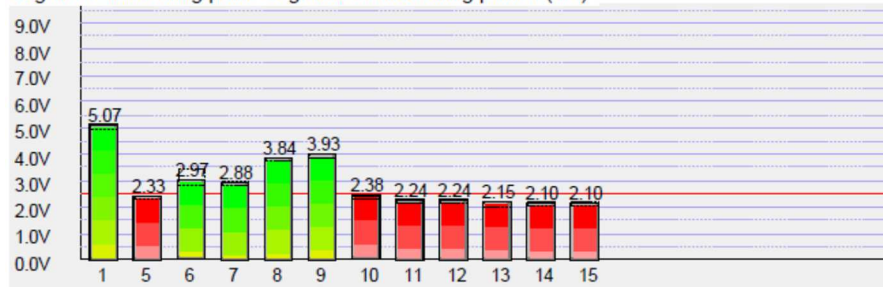
Figura 3 - Antes da intervenção

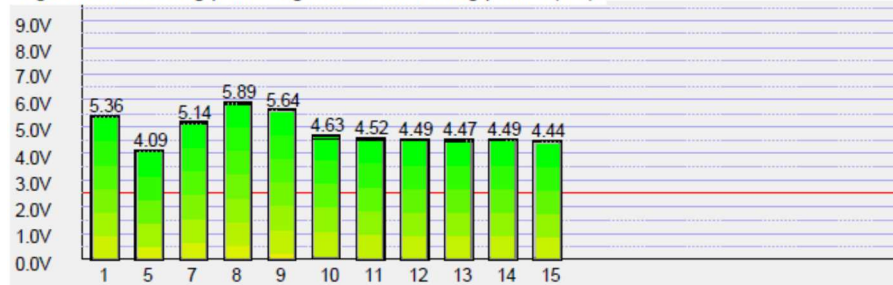
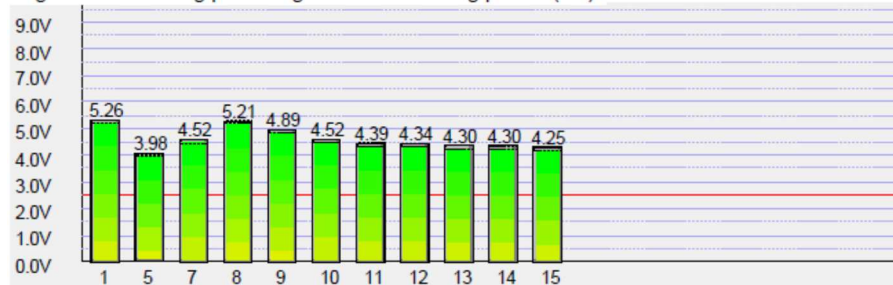
Figura 4 - Após a intervenção (Dispositivo 6 ausente devido a manutenção no inversor de média tensão)

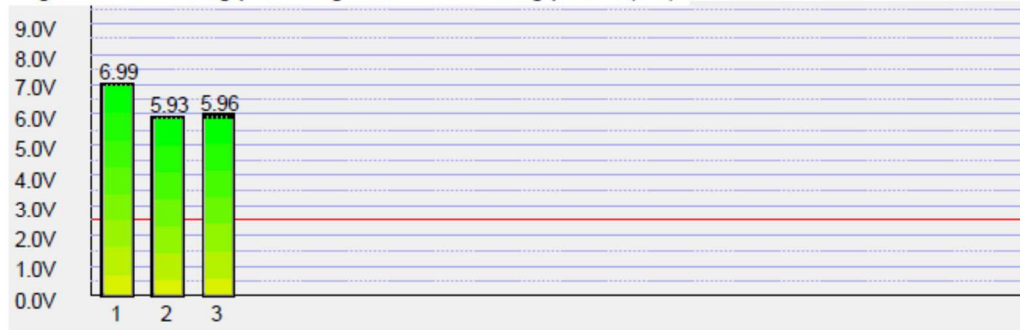
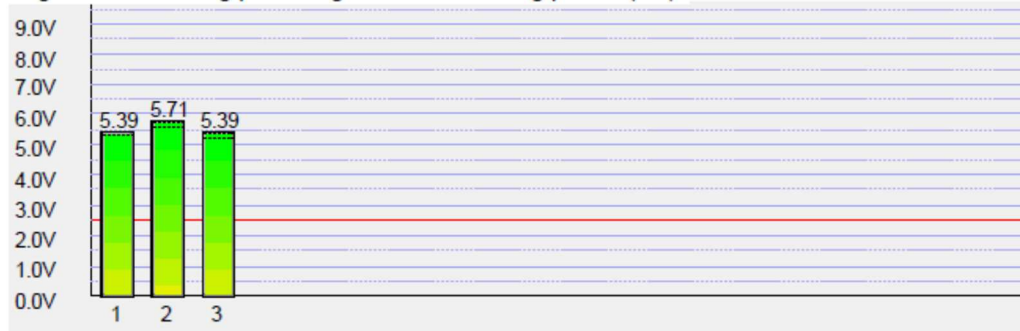
Figura 5 – Sem necessidade de intervenção

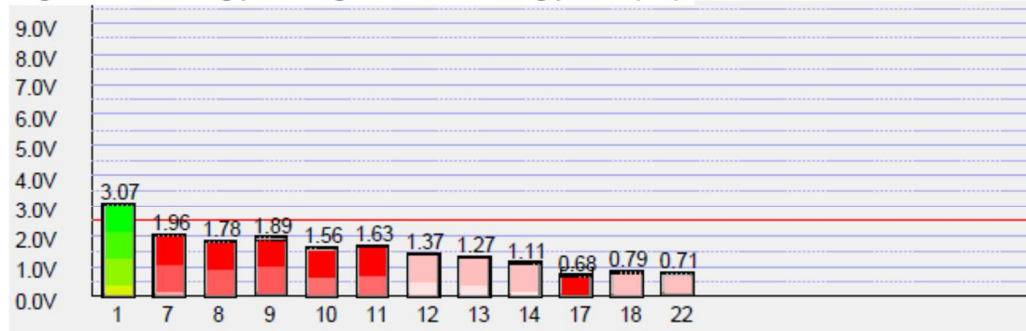
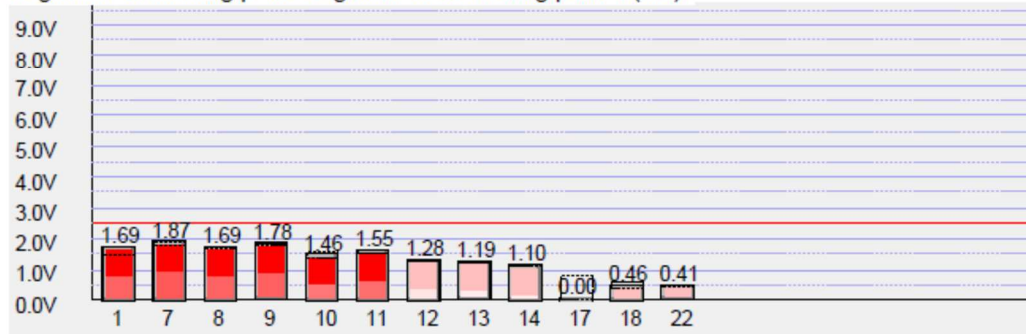
Figura 6 - Antes da intervenção (Encontrado equipamento com defeito)

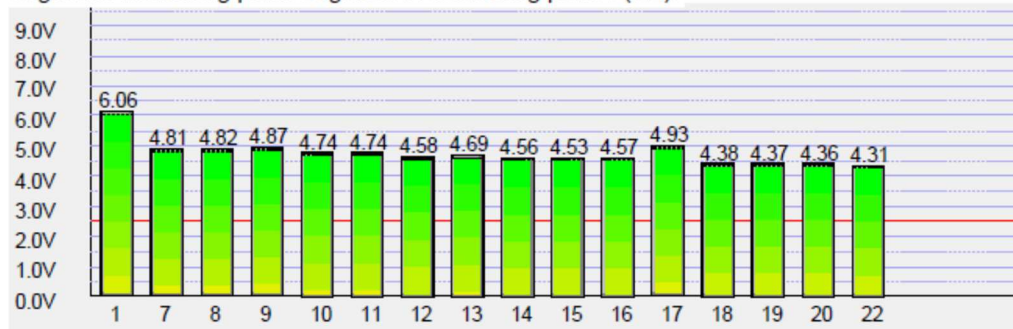
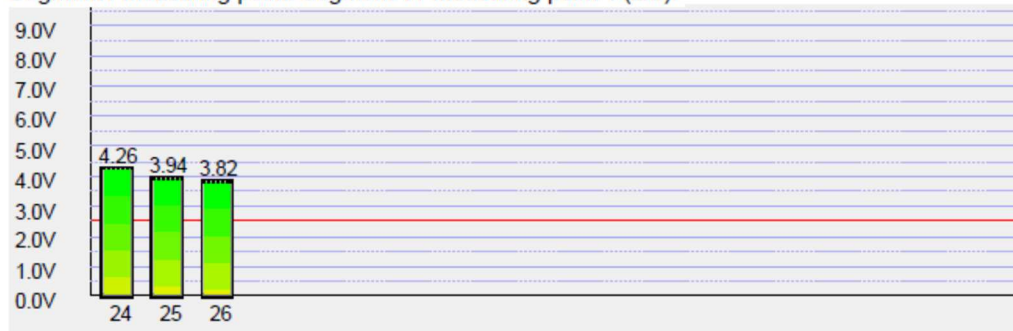
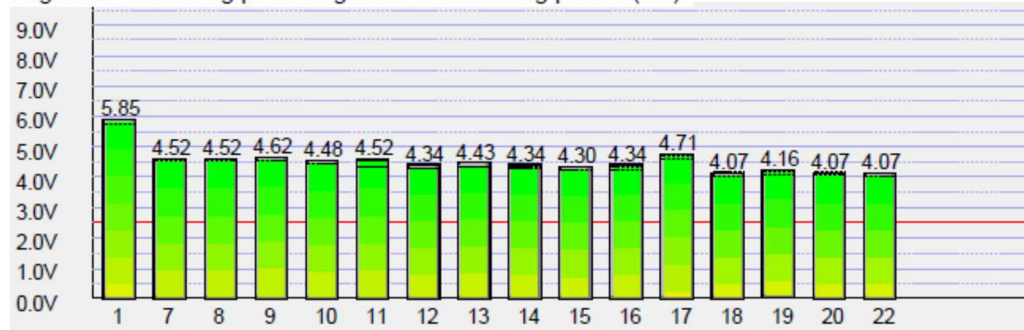
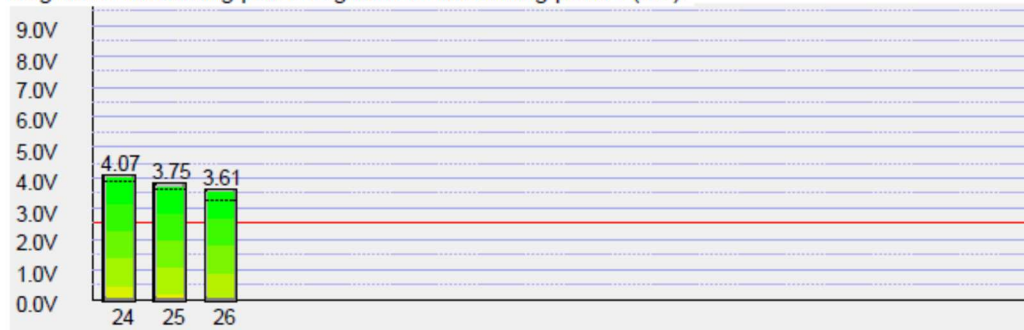
Figura 7 - Após a intervenção (Equipamento defeituoso substituído)

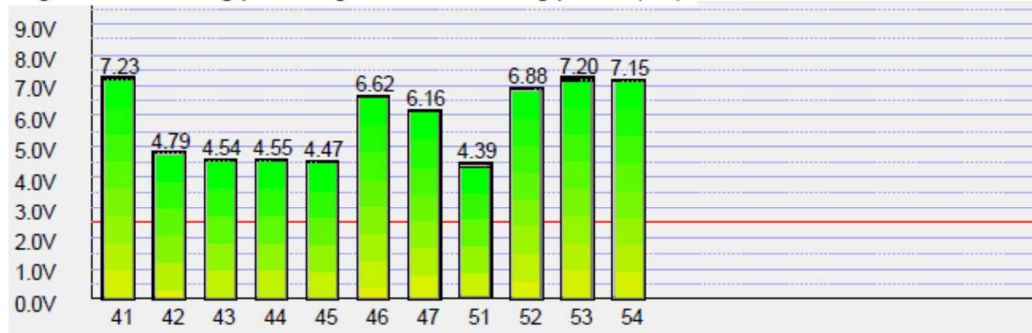
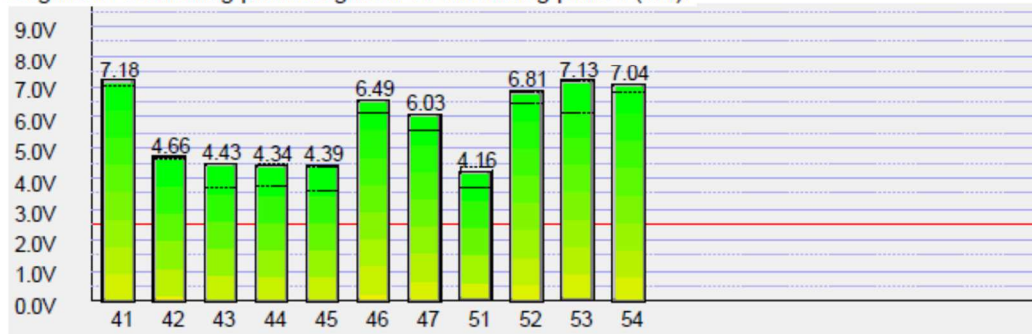
Figura 8 – Sem necessidade de intervenção

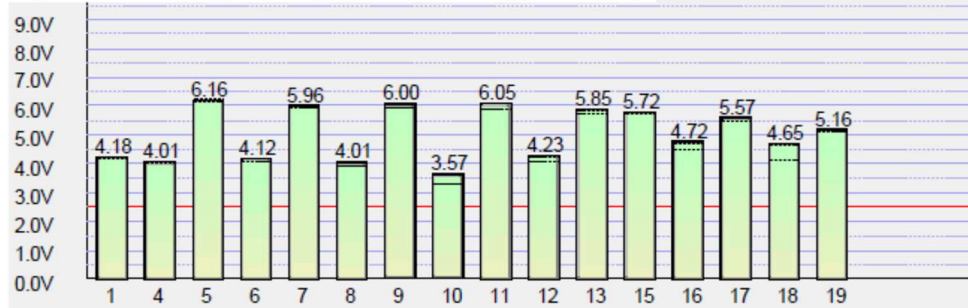
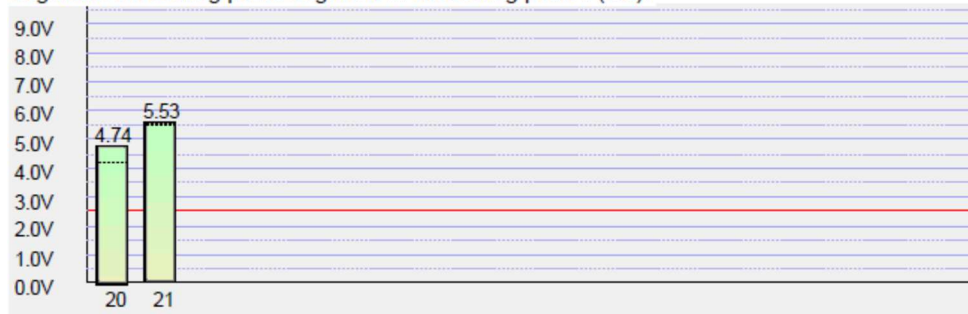
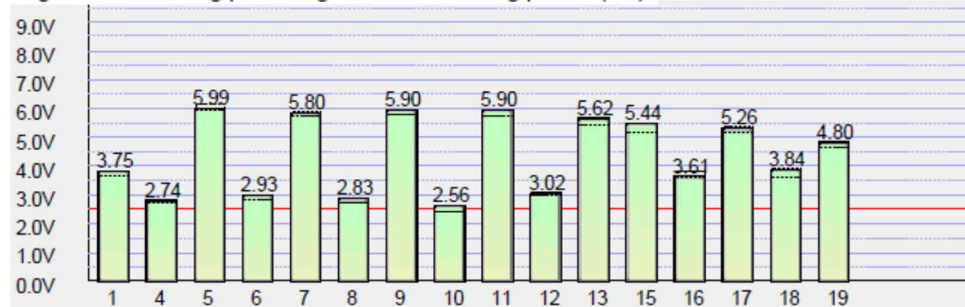
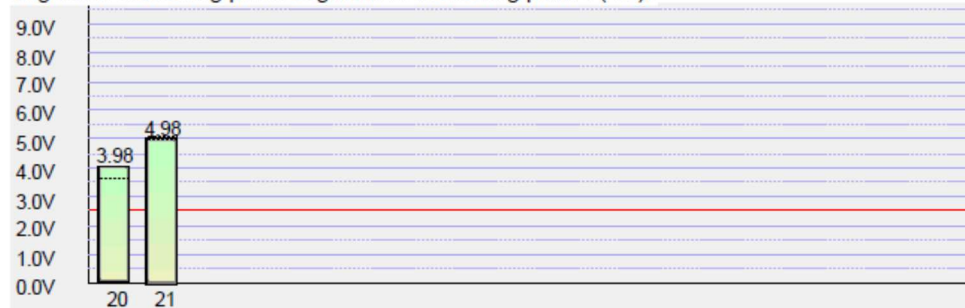
Figura 9 - Antes da intervenção

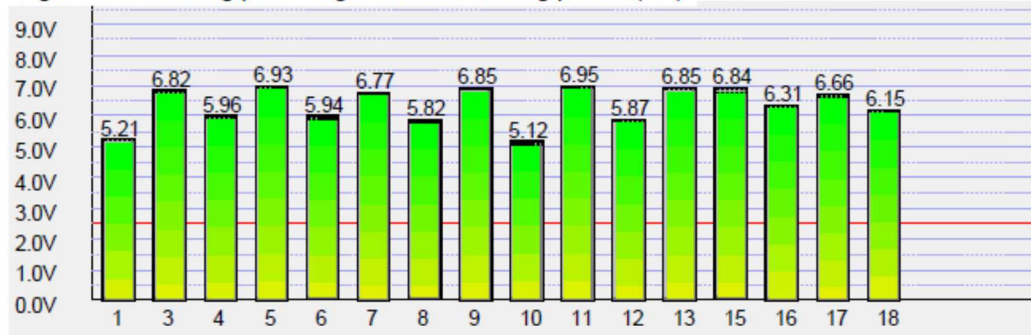
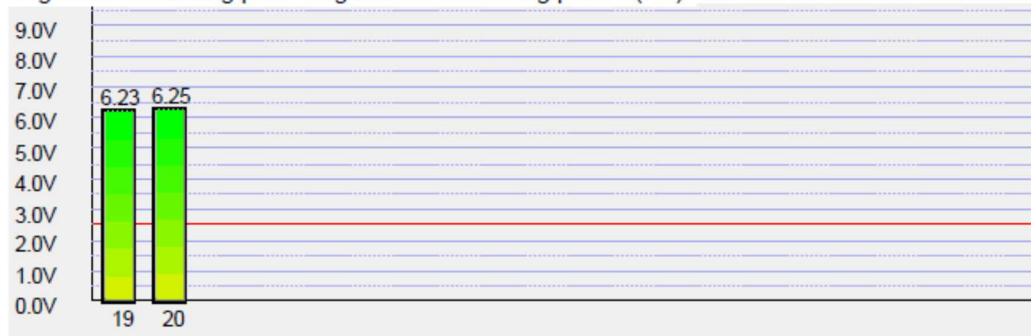
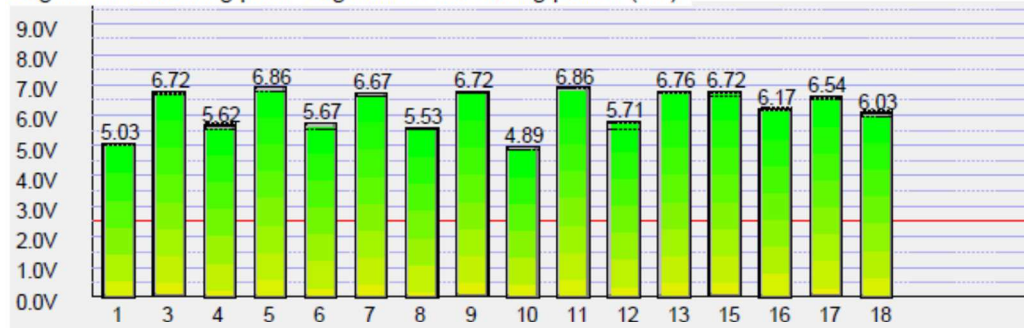
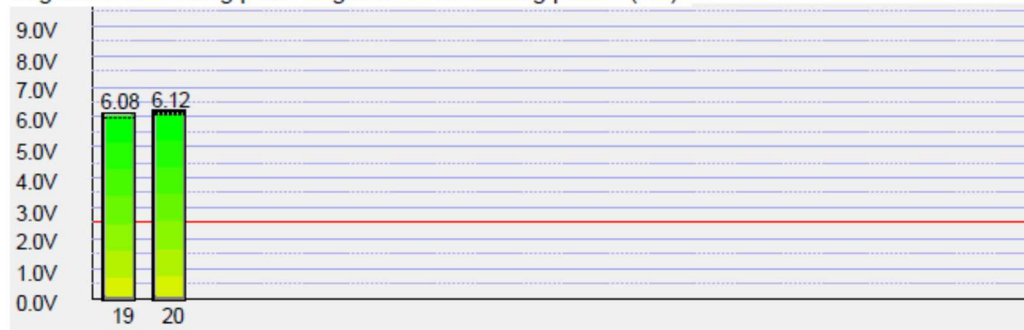
Figura 10 - Após intervenção

Todas as sete redes Profibus da ETA Reis Magos tiveram sua velocidade reduzida.

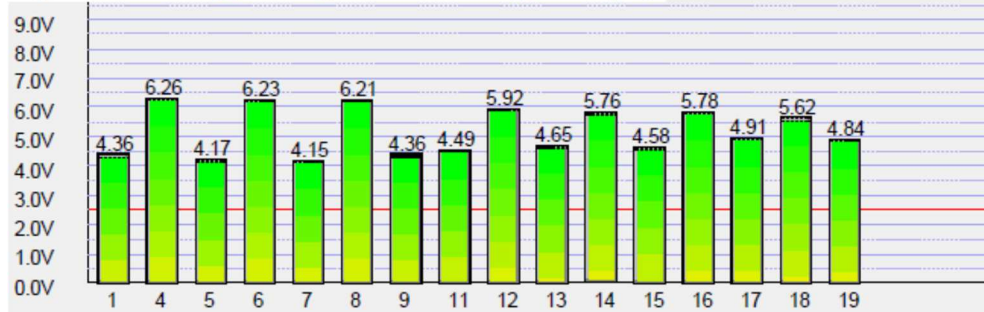
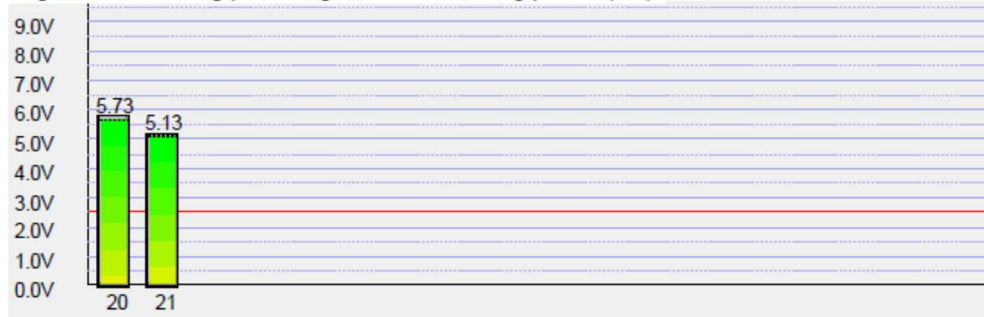
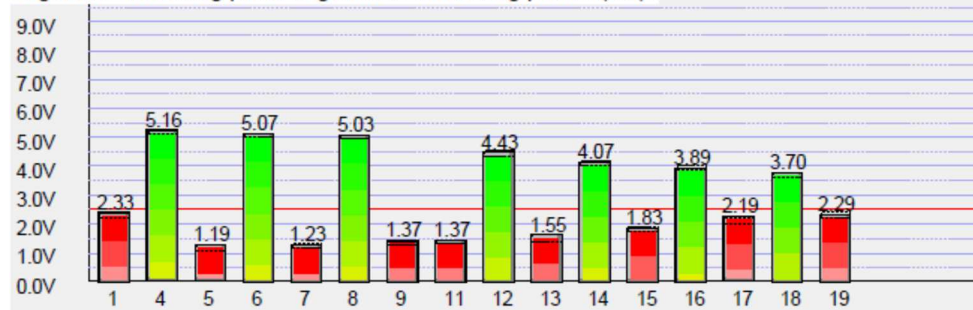
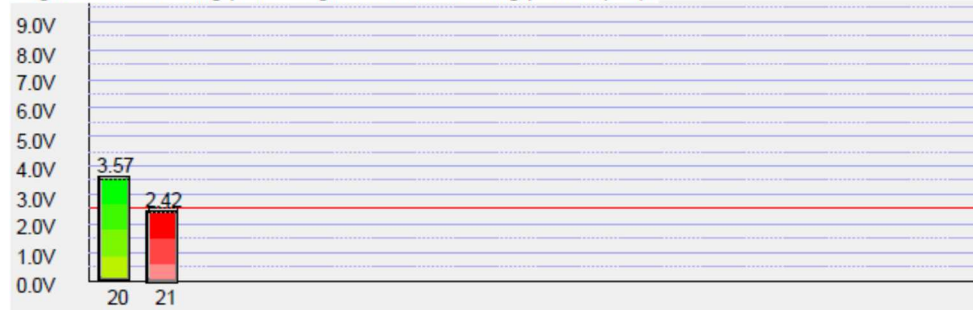
Figura 11 - Antes da intervenção

O arquivo com as intervenções realizadas na ETA II corrompeu-se, porém, seus dados ficaram similares aos da ETA I.
